Manhole Inspection Summary

Manhole # S29CC_011MH

Insp Date: 1/12/07 8:39 AM

Location Address: **443 MCCULLOH ST**

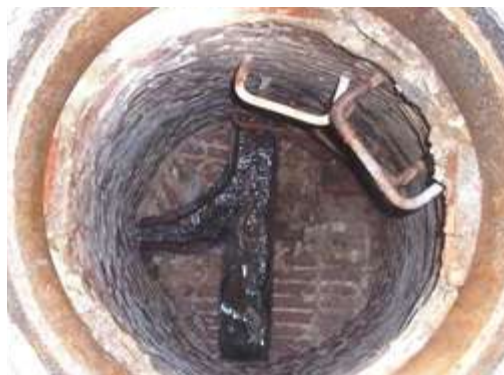
Top View

Corroded steps. Evidence of surcharge - Bench debris. Channel debris.

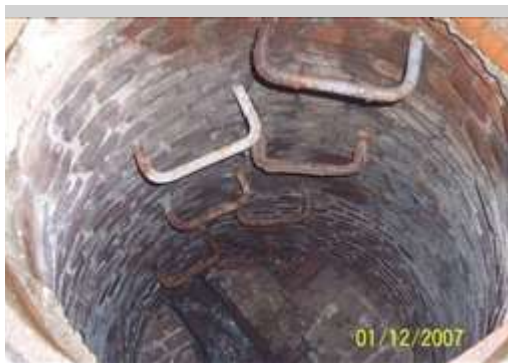
Defect

Corbel infiltration.

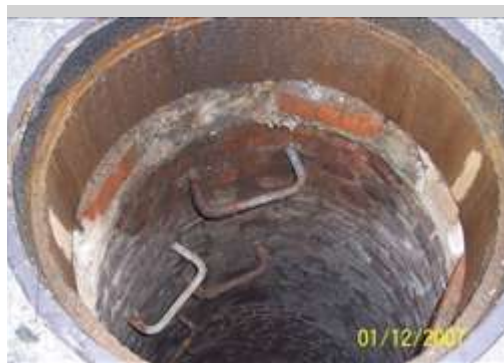
Defect

Frame leaks. Frame offset. Adjustment deterioration, loose brick and infiltration. Corbel infiltration.

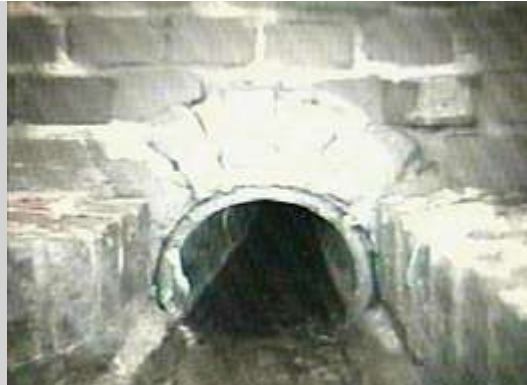
8 in. Circular Gravity Sewer Pipe Out @ 12 O'Clock

Channel deterioration.

Deposits: ☐ None ☒ **Mud** ☐ Sludge ☒ **Debris** ☐ Grease

Silt Depth: **1** (in.) Deposits Extent: **Light**

Infiltration: **Evidence** Pipe Seal Cond: **Cracked**

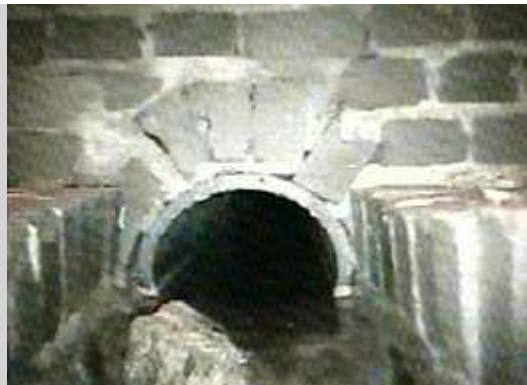
8 in. Circular Gravity Sewer Pipe In @ 6 O'Clock

Deposits: ☐ None ☒ **Mud** ☐ Sludge ☒ **Debris** ☐ Grease

Silt Depth: **0.5** (in.) Deposits Extent: **Light**

Infiltration: **Evidence** Pipe Seal Cond: **Cracked**

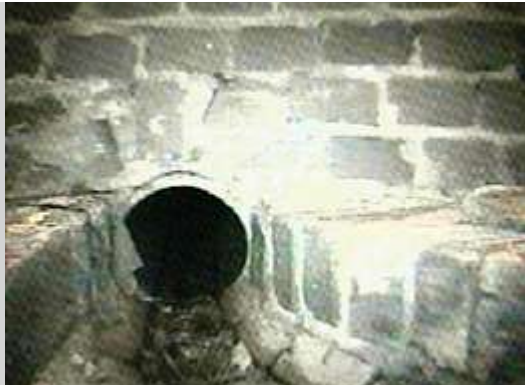
6 in. Circular Gravity Sewer

Deposits: ☐ None ☒ **Mud** ☐ Sludge ☒ **Debris** ☐ Grease

Silt Depth: **0.5** (in.) Deposits Extent: **Light**

Infiltration: **Evidence**
